RAŽENÉ TUNELY OLBRAMOVICKÝ A TOMICKÝ I. NA TRATI VOTICE – BENEŠOV U PRAHY

OLBRAMOVICE AND TOMICE I MINED TUNNELS ON THE VOTICE – BENEŠOV U PRAHY RAIL TRACK

LIBOR MAŘÍK

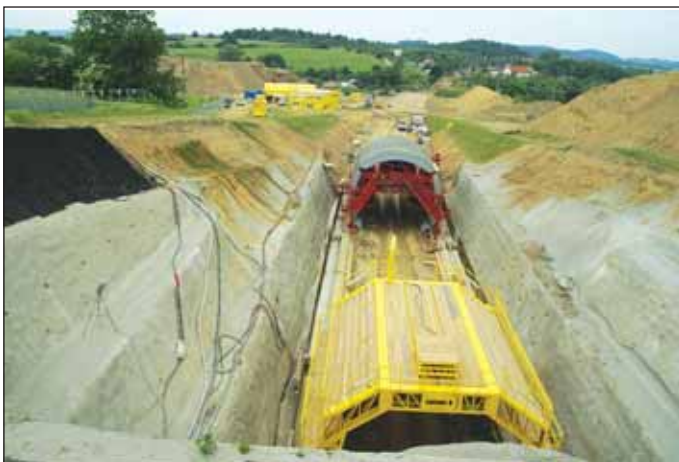
Obr. 3 Svahovaná stavební jáma výjezdového portálu
Fig. 3 Sloped construction pit for the exit portal

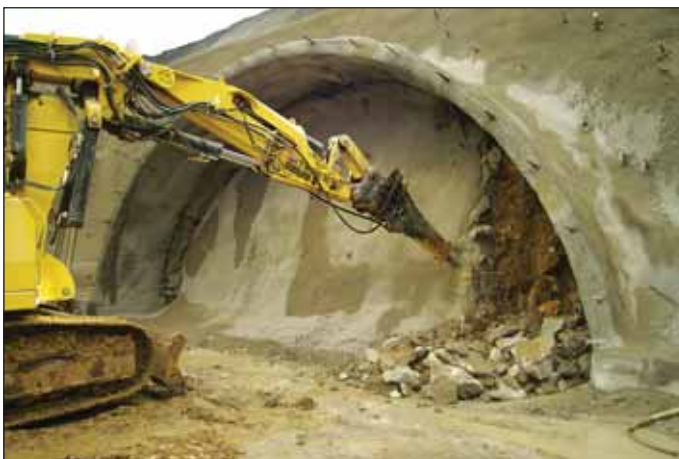
Obr. 4 Zahájení ražby pod zárodkem kaloty
Fig. 4 Commencement of excavation under the top heading stub

betonáže raženého tunelu byly navrženy v technologické třídě výrubu VI. se spodní klenbou (obr. 1). V dalších úsecích tunelu již umožňovaly geotechnické podmínky použít ostění uložené na patkách (obr. 2). V oblasti výjezdového portálu měla zvětřalá zóna zasahovat do kaloty tunelu a kromě rul byla přímo na rozhraní hloubené a ražené části tunelu očekávána poloha granitu. Střídání poloh granitu, biotitických rul a grafitických břidlic o různém stupni zvětrání i tektonického porušení bylo charakteristické pro celou ražbu tunelu. Stavbu zahájilo 1. 11. 2009 hloubení stavební jámy výjezdového portálu. Svahy stavební jámy zajišťují pouze tyčové kotvy délky 4 m a 6 m prováděné do cementové zálivky. Pohled do stavební jámy výjezdového portálu, kde je připraven vůz pro osazování hydroizolační fólie a za ním bednicí vůz, ukazuje obr. 3. Zemní práce probíhaly bez problémů a po zajištění navrženém v projektové dokumentaci byly svahy jámy stabilní, i když zóna zvětrání zasahovala do větší hloubky a poloha granitu nebyla při hloubení, ani po zahájení ražby zastižena. V dolních partiích stavební jámy a na portálovém svahu je proveden kromě kotvení i stabilizační nástřik stříkaného betonu se sítí KARI. Součástí stavební jámy je i zárodek kaloty. Jedná se o konstrukci provedenou z výztužných rámců, sítí a stříkaného betonu, která je pevně založena na železobetonových patkách. Tvarově odpovídá primárnímu ostění v navazujícím raženém úseku. Její úlohou je stabilizovat portálový svah a chránit osádku před případným pádem předmětů z portálového svahu do jámy. Dále tvoří rubové bednění bloku betonáže, který z ražené části tunelu částečně zasahuje do stavební jámy. V neposlední řadě tvoří podporu deštníku z jehel z betonářské oceli $\varnothing 32$ mm délky 6 m, které zajišťují přístropí tunelu při zahájení ražby. Slavnostní okamžik zahájení ražby tunelu pod zárodkem kaloty ukazuje obr. 4.

of objects from the portal slope to the pit. In addition, this structure formed the outer formwork for the tunnel casting block, which partially extended from the mined part into the construction pit. At last but not least, it provided support for a protective umbrella consisting of 6 m long concrete reinforcement bars Ø32 mm, which supported the tunnel top heading when the tunnel excavation was starting. The ceremonial commencement of the tunnel excavation under the top heading stub structure is shown in Fig. 4.

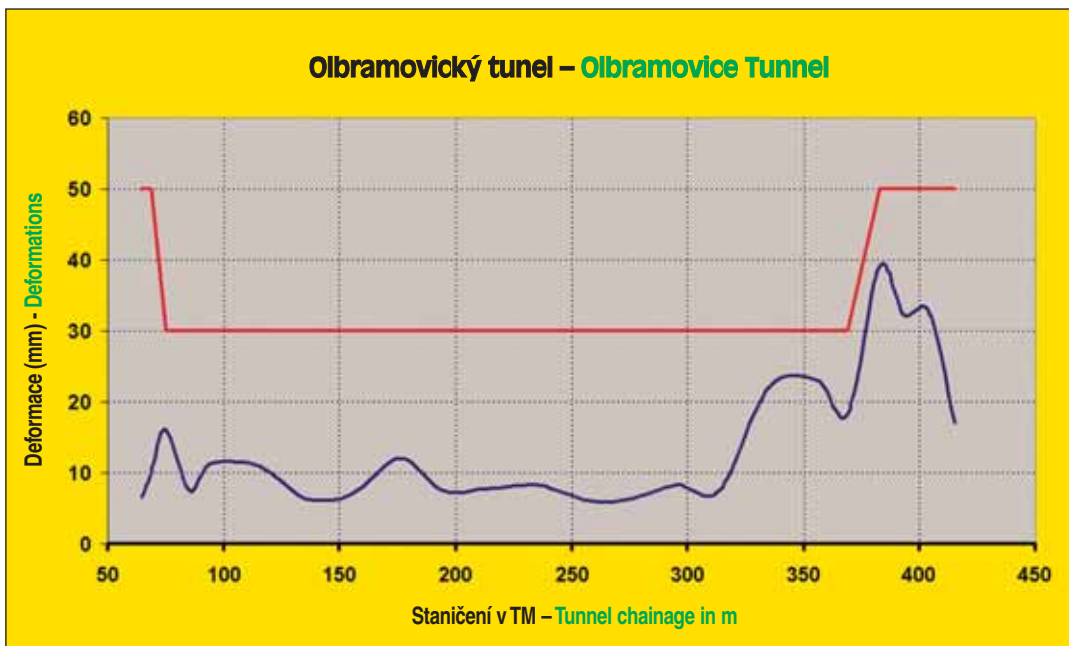
Obr. 5 Průběh naměřených a předpokládaných deformací výrubu
Fig. 5 Curves for measured and anticipated deformations of the excavation

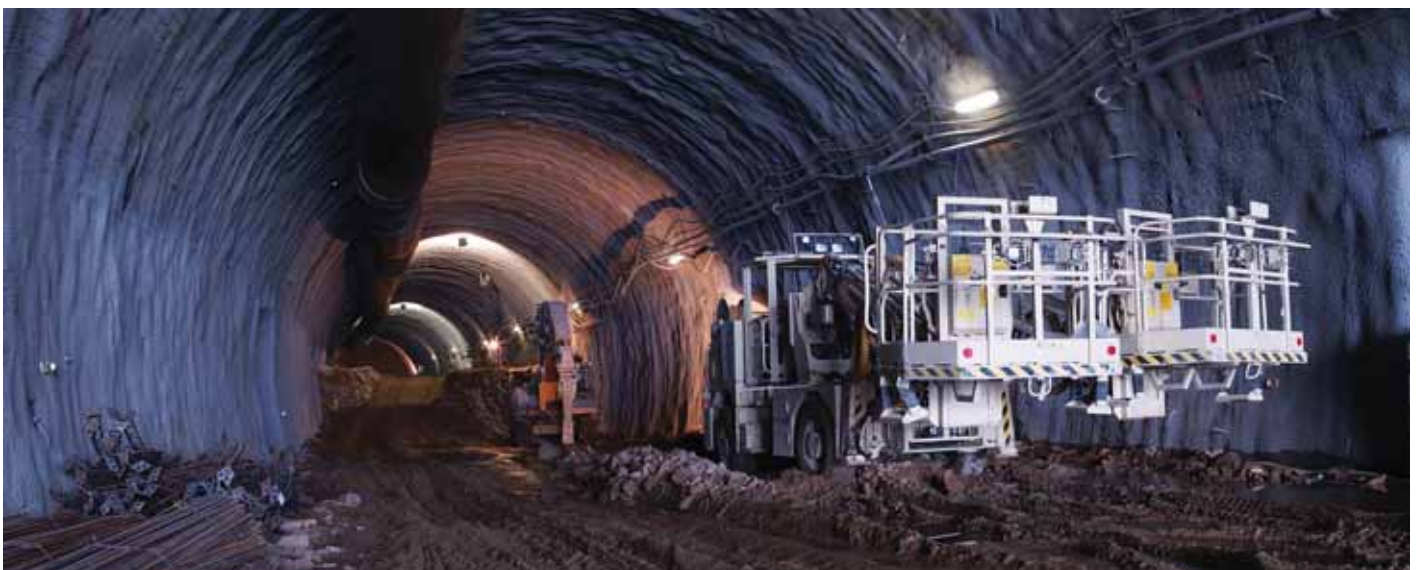
Obr. 6 Členění výrubu na kalotu a opěří
Fig. 6 Excavation sequence consisting of top heading and bench

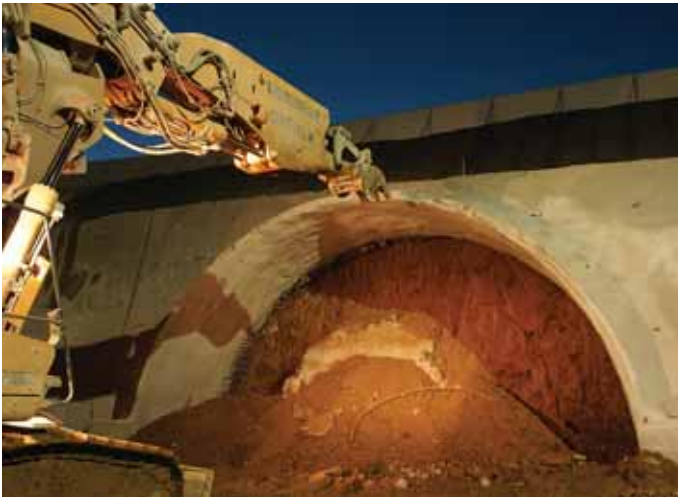
Obr. 7 Silně zvětralé eluvium na čelbě na vjezdovém portále
Fig. 7 Heavily weathered eluvium at the heading at the entry portal

vjezdového portálu, čelba byla zajištěna kotvami a stříkaným betonem a mechanismy byly přesunuty k vjezdovému portálu. O den později 23. 4. 2010 zahájila noční směna protiražbu od vjezdového portálu (obr. 7). Již při hloubení stavební jámy se potvrdily obavy z hloubky zvětrání horninového masivu v oblasti vjezdového portálu. Eluvium v úrovni dna kaloty bylo možné téměř rozpojovat rukou a zhotovitel si vymohl do realizační dokumentace doplnit alternativní zajištění portálu a zahájení ražby mikropilotovým deštníkem. Nakonec však nebyl opět použit a obrys přístropí zajišťoval opět jen deštník z betonářské oceli $\varnothing 32$ mm délky 6 m, tentokrát navrtaný ve dvou řadách nad sebou. Raziči firmy Subterra přistupovali k zahájení ražby velmi zodpovědně a s patřičným respektem. Výrub kaloty o ploše 60 m^2 s nadloží 5 m až 8 m probíhal bez problémů a nadvýrubů a záhy zhotovitel zjistil, že se nejedná o nic nebezpečného a že jehly poskytují dostatečnou bezpečnost pro ražbu i staveništní komunikaci v nadloží. Po dobu ražby pod komunikací byl však na ni přerušen provoz. Vzhledem k hloubce zvětrání byla na rozdíl od výjezdového portálu nasazena technologická třída výrubu VI. se spodní klenbou. Rozsah úseku se spodní klenbou určoval na základě skutečně zastížených podmínek geotechnik stavby s tím, že s ohledem na betonáž definitivního ostění musela délka úseku odpovídat násobkům délky bloku betonáže, tj. 12 m. V tomto případě se skutečná délka úseku ve třídě výrubu VI. shodovala s prognózou určenou v zadávací dokumentaci.

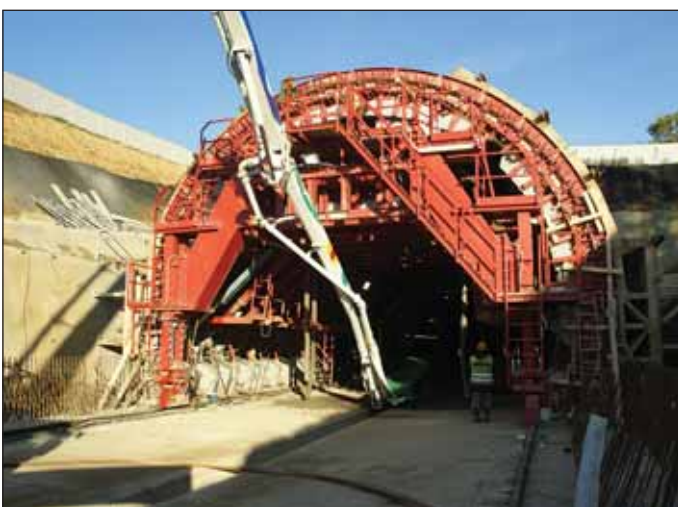
Obr. 8 Bednicí vůz ve stavební jámě
Fig. 8 Traveller formwork in a construction pit

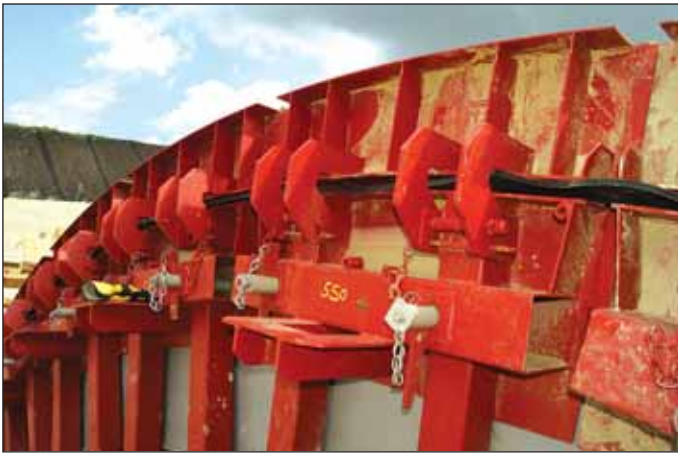
Obr. 9 Speciální úprava čela bednění pro těsnicí pás

Fig. 9 Special design for the end of the formwork for the insertion of a waterstop

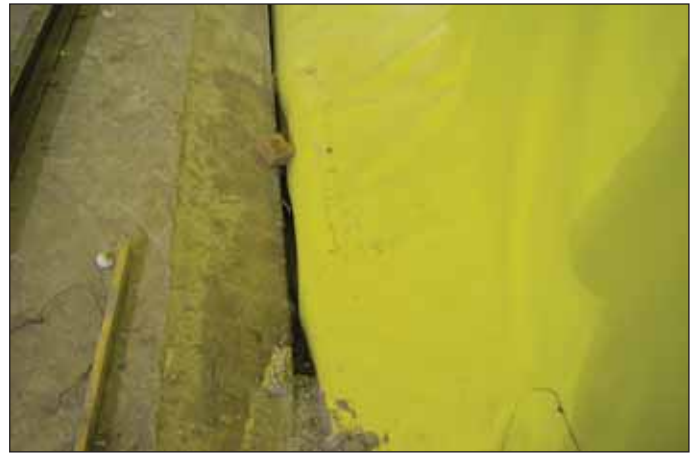
Obr. 10 Koncová úprava hydroizolační fólie v místě patky ostění

Fig. 10 Final design for the waterproofing membrane at the foot of the lining

Ražená část tunelu je izolována hydroizolační fólií, která je podélně svařena dvoustupým, kanálkovým svarem s možností zkoušení natlakováním. Pro napojení klenby a patky je použit již standardní detail bez propojení výztuže a se zatažením hydroizolační fólie až do úrovně bočních drenáží (obr. 10). Ty jsou uloženy pod úrovní spáry mezi klenbou a patkou, takže hydroizolační fólie izoluje i tento citlivý detail s vodorovnou spárou. Kromě poškození hydroizolační fólie při montáži výztuže je nutno pečlivě sledovat i provádění zdvojení fólie v místě spáry mezi bloky betonáže a ukončení fólie v místě patky. Nedostatečné utěsnění fólie k patce ostění způsobilo v minulosti řadu problémů, kdy při doinjektování vrchlíku definitivního ostění došlo k zatečení injektážní směsi do drenážního systému a zabetonování potrubí. Sanace je časově i finančně velmi nákladná a zpravidla se neobejde bez trvalého poškození drenážního systému. Stejným způsobem může být drenážní systém poškozen, pokud není během provozování

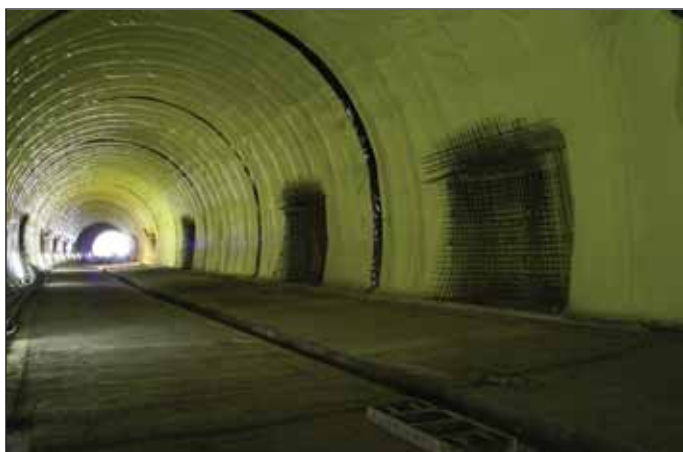
Obr. 11 Úsek tunelu s nevyztuženým ostěním
Fig. 11 Tunnel section with non-reinforced concrete lining

V ražené části tunelu je definitivní ostění navrženo z betonu C20/25. Dimenzování probíhá na základě výsledků deformačních měření prováděných v rámci geomonitoringu. Použitím primárního ostění tloušťky 200 mm až 250 mm a díky vysoké stabilitě horninového prostředí došlo během ražby jen k minimálním deformacím. Zpětnou analýzou byly na základě deformací odvozeny geotechnické parametry horninového masivu a následně zatížení ostění, které se blíží reálným podmínkám. Při nelineárním výpočtu betonového ostění, kdy je zohledněn vznik trhlin a tím i maximální využití průřezu, lze větší část raženého tunelu provádět bez výztuže. Proto jsou vyztuženy pouze bloky betonáže v příportálových úsecích a v nevyztužených blocích betonáže jsou vyztuženy jen nouzové výklenky v každém druhém bloku (obr. 11). Díky možnosti

the casting blocks in the portal sections were reinforced. In the unreinforced blocks, only the emergency recesses in every other block were reinforced (see Fig. 11). Thanks to the possibility to close the portals and the travelling formwork with geotextile, concrete could be cast even during the winter season. During the preparation of this paper, the final lining had been completed throughout the tunnel length and the work on the inner equipment of the tunnel was in progress.

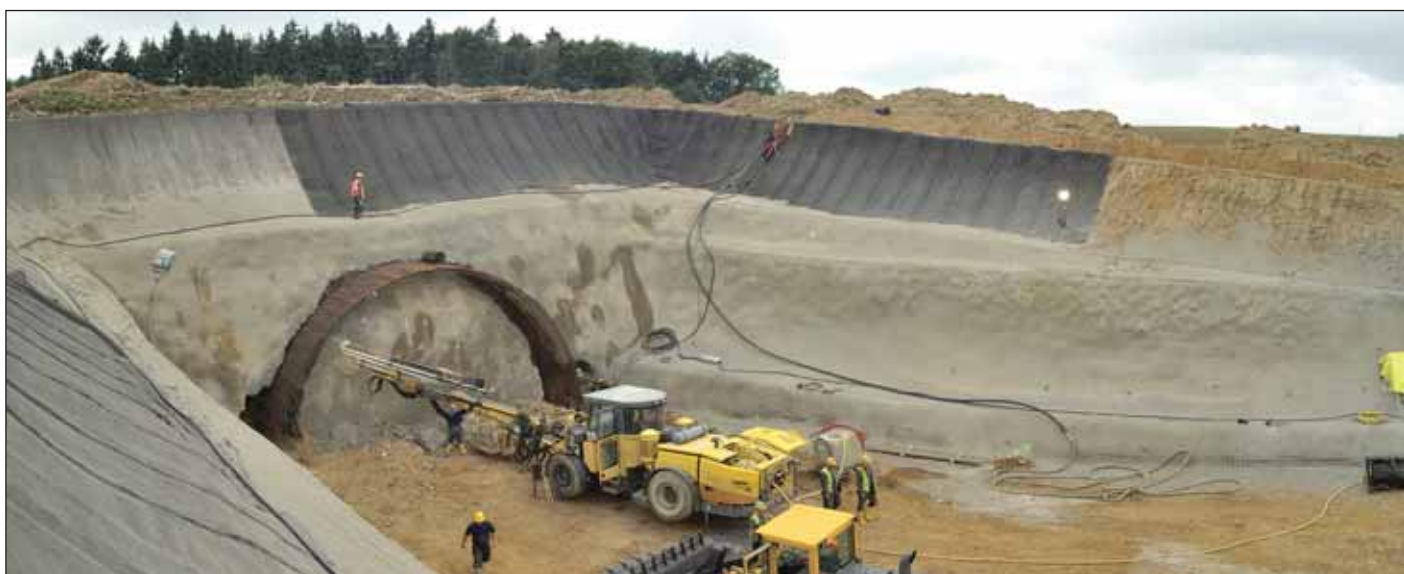
Obr. 12 Stavba zárodku kaloty v jámě Tomického tunelu I.
Fig. 12 Construction of the starting top heading stub in the construction pit for the Tomice tunnel I.
