REALIZAČNÍ DOKUMENTACE DEFINITIVNÍHO OSTĚNÍ TUNELU LIBOUCHEC

DETAILED DESIGN FOR THE FINAL LINING OF THE LIBOUCHEC TUNNEL

LIBOR MAŘÍK, JIŘÍ HOŘEJŠÍ

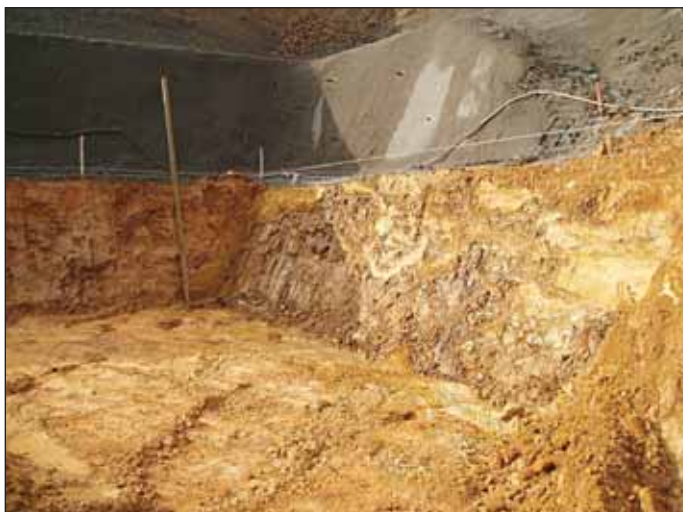
Obr. 1 Jižní portál východního tunelu – zóna zvětrání zasahuje až do úrovně kaloty
Fig. 1 The South Portal of the Eastern Tunnel Tube – the zone of weathering extending to the top heading level

The Libouchec tunnels run across a north-eastern edge of the Krušné Hory crystalline complex formation, which comprises heavily metamorphosed rock types. The up to 3m thick cover consisting of medium compact debris, extremely sandy loams and gravels lies on an up to 4m thick layer of heavily weathered orthogneiss forming the top of the Pre-Quaternary bedrock. Slightly weathered to fresh orthogneiss, mostly heavily faulted, is predicted to be found under this layer. Based on the assessment of the geotechnical exploration, the rock mass was divided into quasi-homogeneous units of ground types featuring similar properties, which were used in the design of the construction trenches' slopes and, in the case of the cut-and-cover tunnel sections, in the design of the NATM excavation classes. The excavation of the construction trench for the south portal showed that the weathering zone above the western tube reaches approximately the anticipated depth and it does not extend into the tunnel cross section; regarding the eastern tunnel tube and, primarily, the rock pillar between the western tube and the construction pit for the eastern tube, the depth of the rock affected by weathering reached the level of the top heading bottom (see Fig. 1). This situation affected the technological procedure designed for the excavation of the construction trenches, the position of the mined portal of the eastern tunnel tube, as well as the lengths of the reinforced sections of the final tunnel lining.

mocnosti 4 m. Pod touto vrstvou se již podle prognózy měly vyskytovat mírně navětralé až zdravé ortoruly, převážně silně tektonicky porušené. Po vyhodnocení výsledků IG průřezu byl horninový masív rozdělen na kvazi homogenní celky obdoby geotechnických vlastností, které sloužily pro návrh sklonů stavebních jam a v případě ražených úseků tunelu pro návrh technologických tříd výrubu. Při hloubení stavební jámy jižního portálu se ukázalo, že nad západním tunelem dosahuje zóna zvětrání přibližně očekávané hloubky a nezasahuje do prostoru tunelu, v případě východního tunelu a zejména horninového pilíře mezi západním tunelem a jámou východního tunelu však zvětralé horniny zasahovaly až do úrovně dna kaloty (viz obr. 1). Tato skutečnost ovlivnila technologický postup odtěžování stavebních jam, polohu ražených portálů východního tunelu i rozsah vyztužených úseků definitivního ostění tunelu.

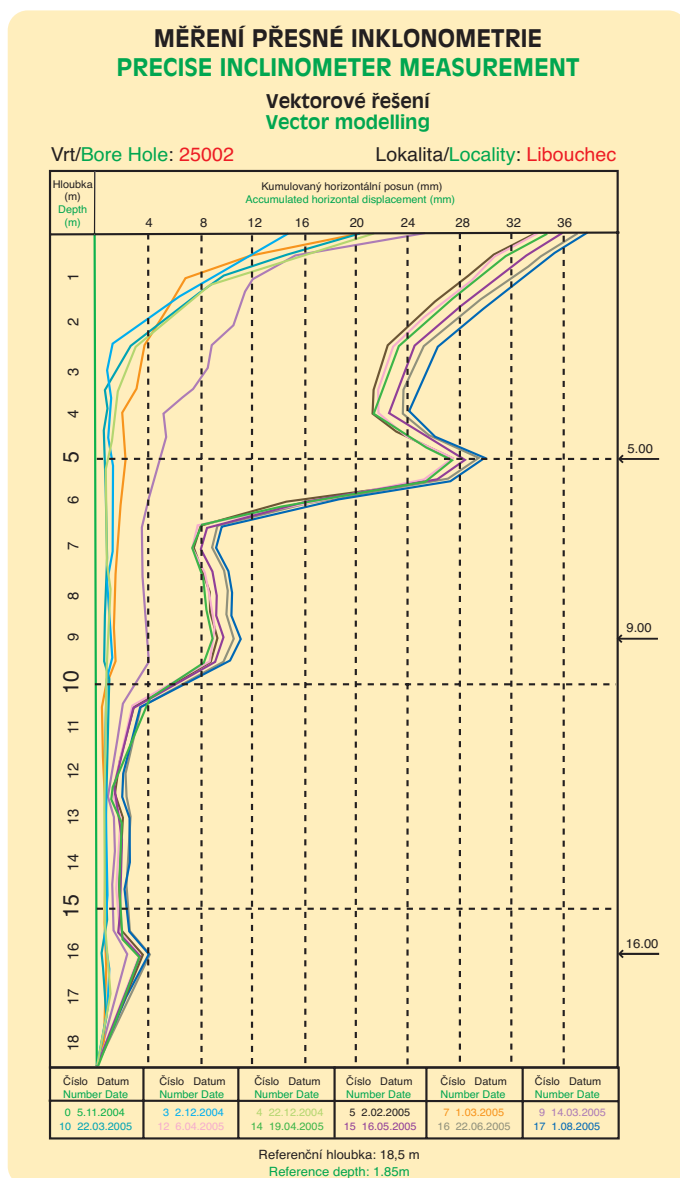
Obr. 2 Deformace horninového pilíře – inklinometrické měření
Fig. 2 Deformation of the rock pillar – the inclinometer measurement

The geotechnical monitoring was carried out throughout the construction of both the mined and cut-and-cover tunnel sections. The displacement of the points fixed on the slopes of the construction trench was observed by surveying methods. Inclinometers installed on the side of the construction trench, above the tunnel profile and in the rock pillar were used to monitor the condition of the construction pit excavation together with the influence of the commencement of the tunnel excavation (see Fig. 2). The excavation deformations were measured at convergence stations having their convergence bolts attached to the surface of the primary lining. The frequency of the measurements and the distance between the monitoring stations corresponded to the construction needs and actually encountered conditions. The measurements were carried out in compliance with the rules set by the design, unless extraordinary situations occurred. Owing to the Barab information system (an Internet-based information system), the results of the measurements could be made available on the Internet immediately after the completion of their assessment to authorised representatives of the parties involved in the construction using their respective access passwords. The excavation operations followed the respective technological procedures defined by the particular excavation classes. The measured values of the excavation deformations lied under the limiting levels determined by the detailed design. The maximum measured value of the vector of deformation in the vicinity of the portal and in the section with the thicker cover not exceeding 30mm and 70mm respectively prove that the rock environment was extraordinarily stable. The advance per round, thus also the excavation advance rate were limited only by the threat of local overbreak which existed due to the extremely narrow spacing of discontinuities. The geomonitoring also consisted of the monitoring of the water table level, the degree of the groundwater aggressive action and the mapping of the excavation face. The geomonitoring results were used during the construction for verification and contingent modification of the technological procedure, both for the mining operations and the excavation of the construction trenches. The assessed results of the excavation deformation measurements contributed to the decision to build unreinforced concrete final lining. Also the FEM mathematical model was de-bugged and the load acting on the final lining was determined according to the actually measured values of the excavation deformation.

Geotechnický monitoring probíhal po celou dobu výstavby hloubených i ražených úseků tunelu. Při hloubení stavebních jam bylo prováděno geodetické sledování posunu bodů osazených na svazích stavební jámy. Inklinometry umístěné na boku jámy, nad profilem tunelu a v horninovém pilíři monitorovaly stav odtěžování jámy i vliv zahájení ražby tunelu (viz obr. 2). V měřických profilech umístěných na lici primárního ostění probíhalo měření deformací výrubu. Četnost měření a vzájemná vzdálenost měřických profilů odpovídala potřebám stavby a skutečně zastiženým podmínkám. Pokud nedocházelo k výjimečným situacím, probíhala měření podle zásad uvedených v projektu monitoringu. Informační systém Barab umožňoval okamžitě po vyhodnocení umístit výsledky měření na internetu a po zadání přístupového hesla jejich zobrazení odpovědným zástupcům stran zúčastněných při výstavbě. Ražba probíhala podle technologického postupu definovaného příslušnou technologickou třídou výrubu a naměřené deformace výrubu ležely pod mezními hodnotami, stanovenými v realizační dokumentaci. Maximální naměřená hodnota vektoru deformace do 30 mm v blízkosti portálu, resp. do 7 mm v úseku s vyšším nadložím svědčí o mimořádně stabilním horninovém prostředí. Délku záběru a tím i rychlost ražby limitovalo pouze nebezpečí lokálních nadvýrubů, ke kterým docházelo kvůli vysoké hustotě diskontinuit. Součástí geomonitoringu bylo i sledování úrovně hladiny podzemní vody a její agresivity a dokumentace čeleb. Výsledky geomonitoringu sloužily během výstavby k ověření a eventuálním úpravám technologického postupu při ražbě i hloubení stavebních jam. Vyhodnocené výsledky měření deformací výrubu přispěly k rozhodnutí o provádění nevyztuženého definitivního ostění. Na skutečně naměřené hodnoty deformací výrubu byl naladěn matematický model MKP a stanoven zatížení definitivního ostění.

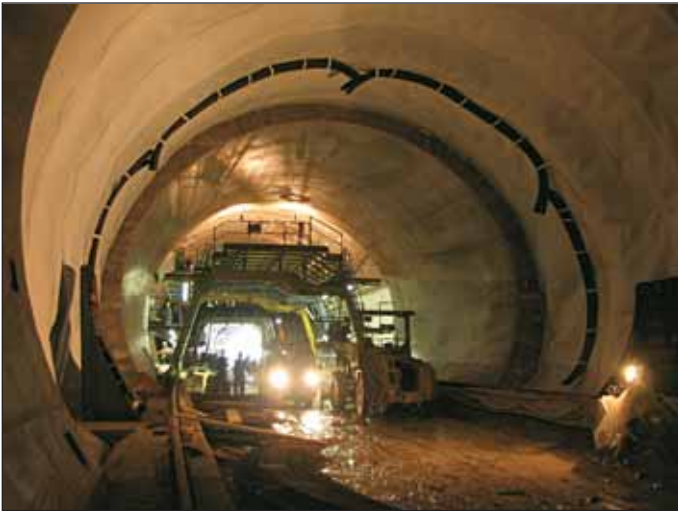
Obr. 3 Šachovnicová betonáž definitivního ostění
Fig. 3 Staggered pattern of the final liner casting

To provide protection of the structure against aggressive environment, the contractor used C25/30 XF4 XD3 concrete for the casting of individual 12m long blocks. In contrast with Austrian guidelines where the protection against the aggressive action is provided by protective coating and where the directive [1] warns against the application of the XF4 concrete because of its propensity for cracking, the protection of the Libouchec tunnel structure against aggressive environment is ensured by the concrete structure itself. The cracking and allowable depth and width of cracks were the frequent topic of many discussions. The fears concerning the randomly spreading shrinkage cracks did not materialize in the course of the casting. The structure did not exhibit any cracks, either when the shutter had been struck or in the period ending by the preparation of this paper. The first of the completed blocks were an exception. Cracks up to 1mm wide originated in the vicinity of the joints between the casting blocks. Even local reinforcement of the given area with steel mesh failed to prevent this phenomenon. A similar phenomenon had been experienced during the casting of the final lining of the Březno u Chomutova tunnel. The author of the detailed design consulted this problem with the contractor and decided to change the concrete casting system from a continuous sequence to a staggered pattern (see Fig. 3). The cracks did not appear again. They had probably been caused by the vibration of the travelling shutter, which was transferred via its jacket into the lining of the block which had not long since been stripped.

Pro betonáž jednotlivých sekcí délky 12 m použil dodavatel beton C25/30 XF4 XD3. Důvodem je ochrana konstrukce proti agresivitě prostředí. Na rozdíl od rakouských doporučení, kde ochranu proti agresivitě zajišťuje ochranný nátěr a kde směrnice [1] varuje před použitím betonu XF4 z důvodu větší náchylnosti ke vzniku trhlin, zajišťuje v případě tunelu Libouchec ochranu proti agresivitě prostředím přímo betonová konstrukce. Vznik trhlin, jejich přípustná hloubka i šířka byly častými tématy mnoha jednání. Při vlastní betonáži se však obavy z šíření divokých smršťovacích trhlin nepotvrdily. Konstrukce nevykazovala po odbednění ani v období do zpracování textu článku žádné trhliny. Výjimku tvořil případ prvních betonovaných bloků, kde ve vrcholu klenby docházelo ke vzniku trhlin šířky do 1 mm v blízkosti spáry mezi bloky betonáže a nepomáhalo ani lokální vyztužení dané oblasti vložením betonářské sítě. Obdobné zkušenosti jsou známy z betonáže definitivního ostění železničního tunelu Březno u Chomutova. Po poradě s dodavatelem navrhl zpracovatel RDS změnit postup betonáže z plynulého na šachovnicový (viz obr. 3). Trhliny se na takto betonovaných blocích již neobjevily. Ke vzniku trhlin docházelo pravděpodobně negativními účinky vibrační bednicího vozu, které se přenášely jeho pláštěm do čerstvě odbedněného bloku ostění.

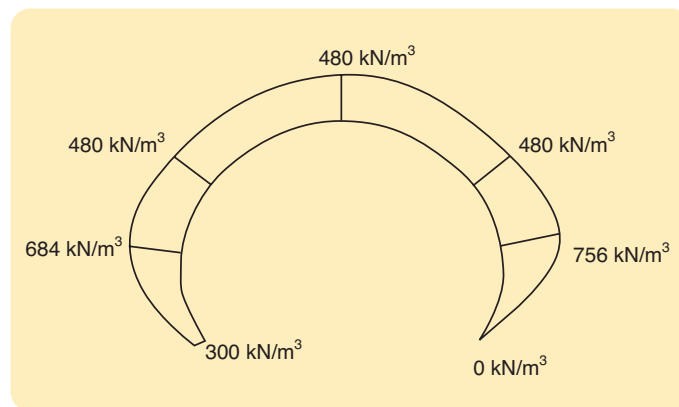
Obr. 5 Mezní hodnota zatížení horninovým tlakem
Fig. 5 The limit value of the confining pressure

The results of the analysis of the unreinforced liner showed that in terms of cracking, the critical combinations do not include the confining pressure as a load. In practice, this is the state existing in the stage early after the casting of the concrete final liner where all of the loads are carried by the primary liner. From the aspect of the origination and opening of cracks, the confining pressure acts positively, i.e. the depth and width of cracks diminishes under the confining pressure. The ultimate limit state was reached when the confining pressure at the crown of the arch assumed a value of 480kPa (see Fig. 5). The critical load case further comprised the dead weight of the structure, heating of the structure in the summer season, shrinkage, creep and forces induced by the tunnel equipment. The anticipated value of the contact pressure between the primary liner and the ground that was calculated by means of the FEM analysis did not exceed 80kPa at the crown of the arch. It follows from the above discussion that the confining pressure would have to rise 6x in comparison with its anticipated realistic value to achieve the ultimate limit state.

Výsledky výpočtu nevyztuženého ostění ukázaly, že kombinace zatížení rozhodující pro vznik trhlin neobsahují zatížení horninovým tlakem. V praxi se jedná o stav v raném stádiu po betonáži definitivního ostění, kdy veškeré zatížení přenáší primární ostění. Horninový tlak působí z hlediska vzniku a rozvětvení trhlin pozitivně, tj. při zatížení horninovým tlakem se snižuje jak hloubka, tak i šířka trhlin. Mezního stavu únosnosti bylo dosaženo pro hodnotu horninového tlaku ve vrcholu kaloty 480 kPa (viz obr. 5). Dále v rozhodujícím zatěžovacím stavu figurovala vlastní váha konstrukce, oteplení konstrukce v létě, smršťování, dotvarování a zatížení od technologického vybavení tunelu. Očekávaná hodnota kontaktního napětí mezi primárním ostěním a horninou, vypočtená pomocí MKP, nepřesahovala ve vrcholu kaloty 80 kPa. Z uvedeného vyplývá, že pro dosažení mezního stavu únosnosti by musel horninový tlak v porovnání s jeho předpokládanou reálnou hodnotou vzrůst 6krát.

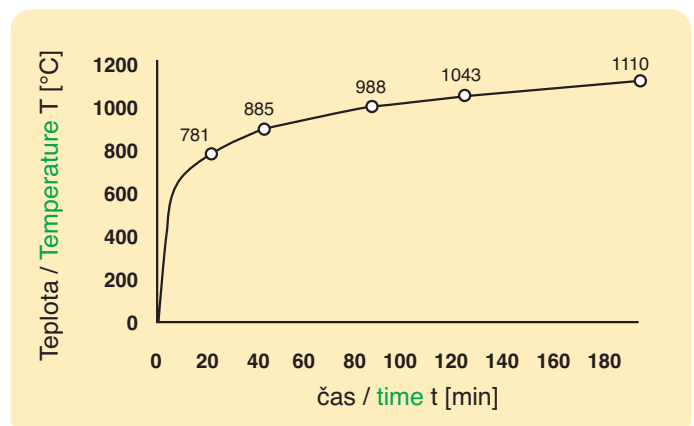
Obr. 6 Normový průběh teploty při zkoušce – celulózová teplotní křivka
Fig. 6 Standard temperature/time cellulosic curve

400mm. This requirement was presented as a condition for the application of unreinforced concrete lining in the Libouchec tunnel. To cope with this condition, the contractor decided immediately to cast a sample of the lining under the conditions existing in the Panenská tunnel. The specimen, which was prepared and cured according to an approved technological procedure, was exposed to climatic effects simulating the tunnel environment. Each of the 5 boreholes drilled into the specimen was provided with 7 temperature sensors fixed at 50mm intervals throughout the thickness of the slab. Other sensors were applied to the unheated surface. The aim of the experiment was to determine the thickness of the concrete layer that are expelled when the specimen is exposed to fire, the depth-temperature curve and the depth of the spalling of the concrete surface exposed to a fire. The specimen was supplied to a credited testing laboratory on 26.10.2005. It was tested on 8.12.2005 and subsequently stored in an environment featuring a minimum relative humidity of 53% and temperature lower than 13°C. The temperature stressing of the specimen proceeded according to the standard cellulosic curve for 180 minutes. The testing according to the standard CSN EN 1363-1 was performed in a vertical wall-type testing furnace heated by a system of petroleum burners. The temperature inside the furnace was measured in one-minute intervals by 7 sensors installed at a distance of 100mm from the surface of the specimen being tested. The standard curve function is described by the equation: $T_n = T_0 + 345 \log(8t + 1)$ which is graphically presented in Fig. 6.

vzorku probíhalo podle normové celulózy křivky po dobu 180 minut. Zkouška podle ČSN EN 1363-1 proběhla ve svislé stěnové zkušební peci vytápěné soustavou naftových hořáků. Teplotu v peci měřilo v minutových intervalech 7 čidel ve vzdálenosti 100 mm od ohřívání líce vzorku. Funkci normové křivky popisuje rovnice: $T_n = T_0 + 345 \log(8t + 1)$, kterou graficky znázorňuje obr. 6.

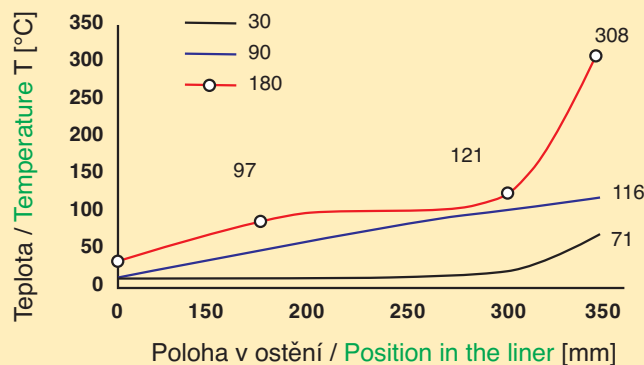
Obr. 8 Teplotní gradient v čase 30, 90 a 180 minut

Fig. 8 Temperature gradient at 30, 90 and 180 minute times

The results of the experiment were surprising for many of us. On one hand, we could expect that the structure would withstand the fire load and the specimen would not be damaged, on the other hand we expected surface spalling caused by vaporisation of water. Neither a single piece of concrete spalled nor a larger crack developed during the course of the test and the subsequent process of cooling of the specimen. Microscopic cracks originated irregularly on the surface of the liner. The tested specimen satisfied the criteria of the limit states of integrity, insulation and radiation specified by the above-mentioned standard. The author of the detailed design plotted the measured values contained in the fire resistance testing report [5] to assess the results graphically. The results of the test show that the temperature achieved at a depth of 50mm under the surface being heated reaches 308°C on average (max. 363°C) at the moment of the end of the testing. The temperature rapidly drops with the growing distance from the heated surface of the specimen; at a depth of 100mm under the surface the average temperature does not exceed 121°C or max. 131°C. The temperature of the reverse surface of the liner, i.e. of the surface which is in contact with the waterproofing membrane in the tunnel, does not exceed a maximum value of 23°C. The chart in Fig. 7 expresses the time dependence of the temperature rise measured by sensors installed at a distance of 100mm, 200mm, 300mm and 350mm from the specimen surface which is not exposed to the heating. The other chart (see Fig. 8) shows the course of temperature along the thickness of the liner, after 30, 90 and 180 minutes.

Výsledky experimentu byly pro mnohé velkým překvapením. I když se dalo očekávat, že konstrukce účinkům požáru odolá a nedojde k destrukci vzorku, byly očekávány povrchové odprysky způsobené uvolňováním páry. Během provádění zkoušky a při následném chladnutí vzorku nedošlo v hloubce 50 mm pod ohříváním povrchem v průměru 308 °C (max. 363 °C). S narůstající vzdáleností od ohřívání líce vzorku dochází k prudkému snížení teploty a 100 mm pod povrchem již průměrná teplota nepřesahuje 121 °C, resp. max. 131 °C. Teplota na rubu ostění, který v tunelu představuje kontakt s izolační fólií, nepřesáhne hodnotu max. 23 °C. Graf na obr. 7 vyjadřuje časovou závislost nárůstu teploty na snímačích umístěných 100 mm, 200 mm, 300 mm a 350 mm od ohřívání líce vzorku. Na druhém grafu (viz obr. 8) je znázorněn průběh teploty po tloušťce ostění v čase 30, 90 a 180 minut.
