# TUNEL LIBOUCHEC NA DÁLNICI D8 – REKAPITULACE TECHNICKÉHO ŘEŠENÍ PŘI UVEDENÍ DO PROVOZU

## THE LIBOUCHEC TUNNEL ON THE D8 MOTORWAY – AN OVERVIEW OF THE ENGINEERING SOLUTION ON THE OCCASION OF THE TUNNEL INAUGURATION

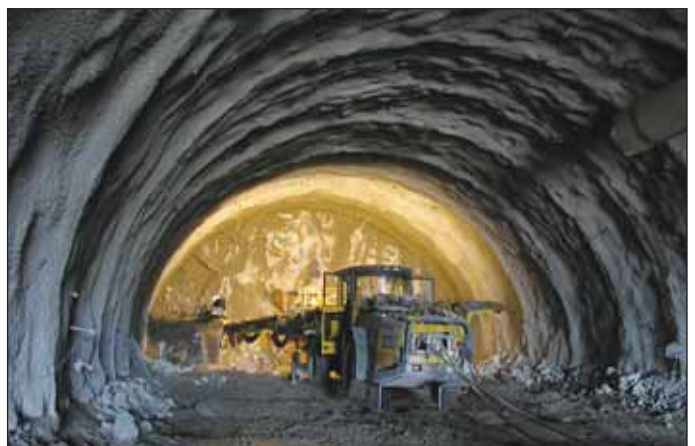
Obr. 2 Ražba kaloty od jižního portálu – 4/2005  
Fig. 2 Top heading drive from the southern portal – 04/2005

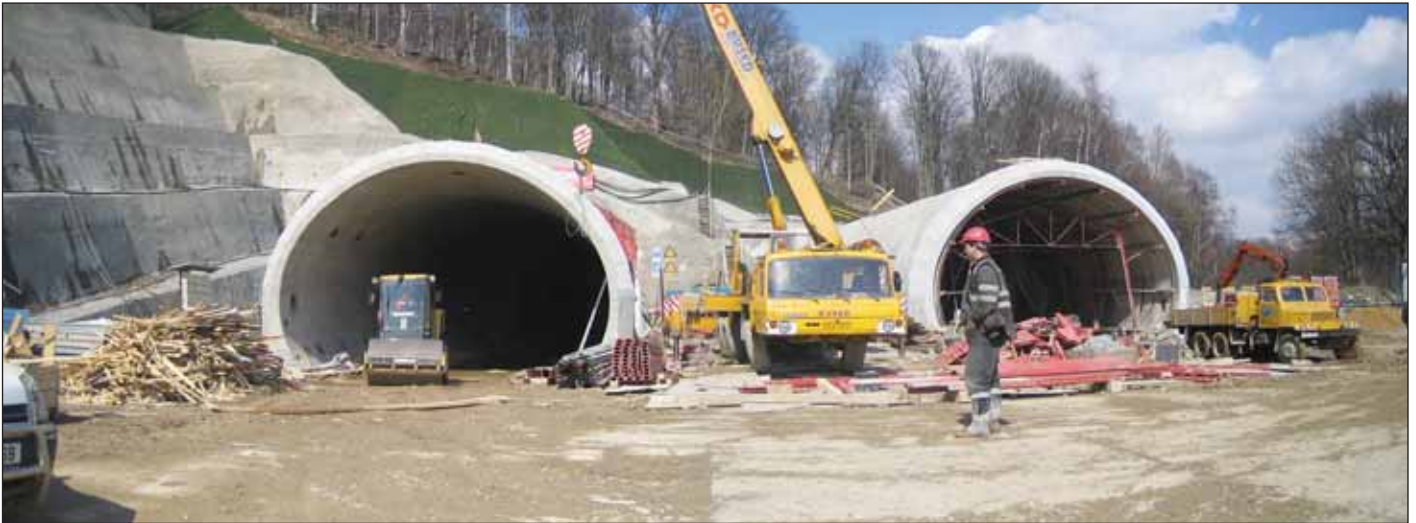
Obr. 4 Hloubené tunely na jižním portále  
Fig. 4 Cut-and-cover tunnels at the southern portal

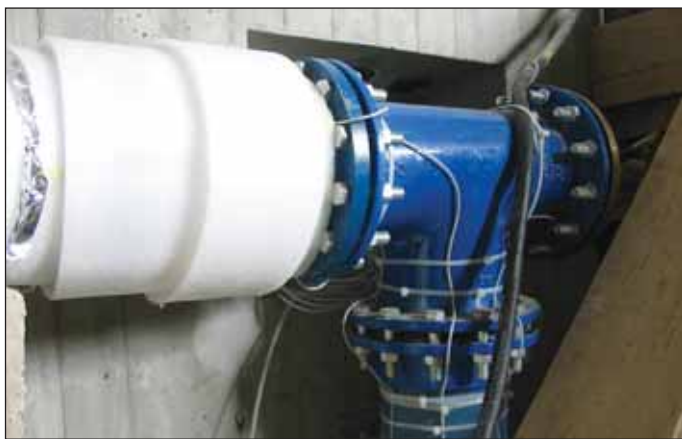
Obr. 6 Ochrana požárního vodovodu před promrzáním  
Fig. 6 Frost protection of the fire main

V souvislosti se změnou polohy požárního vodovodu z původního umístění pod vozovkou do prostoru pod chodníkem vznikl požadavek na temperování potrubí v případě, kdy teplota klesne pod přípustnou mez. Potrubí

A requirement for heating of the fire main pipeline in case of the temperature dropping under an allowable limit appeared in the context of a change in the position of the fire main, from the original place under the roadway to the space under the walkway. A trace heating system is used for the fire main protection, with the heating cables installed between the pipeline external surface and thermal insulation. The heating system is activated by the control system in the case of temperature in the tunnel and on the pipeline surface dropping. This system is in common use in tunnels abroad, but it is the first application in the Czech Republic.

požárního vodovodu je kontaktně ohříváno pomocí topných kabelů instalovaných mezi lícem trubky vodovodu a tepelnou izolací. Při poklesu teploty v tunelu a na líci potrubí vodovodu aktivuje řídicí systém v tunelu otáčení potrubí. Jedná se o systém, který je v zahraničních tunelech běžně používán, v České republice je použit v dálničním tunelu poprvé.

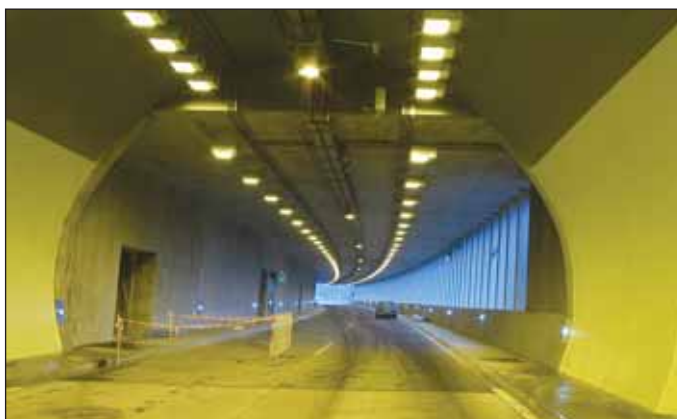
Obr. 7 Přejít z tunelu do galerie  
Fig. 7 Transition of the tunnel to the gallery

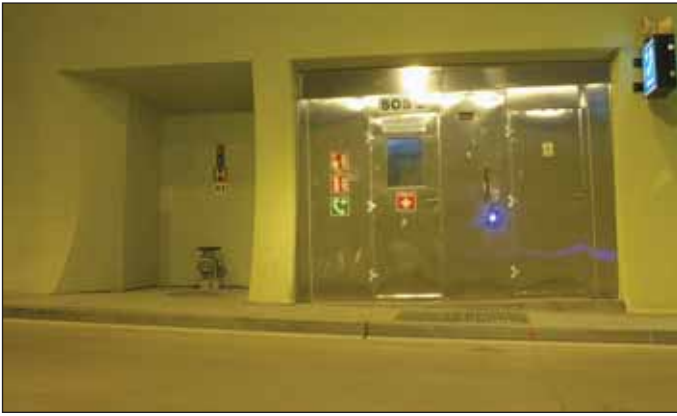
Obr. 8 Sdružený výklenek požárního hydrantu a skříně SOS  
Fig. 8 An SOS niche with a fire hydrant

Hydranty požárního vodovodu jsou stejně jako šachty na čištění boční tunelové drenáže umístěny ve výklencích, jejichž hrany jsou zkoseny ve směru jízdy. Toto opatření omezuje možnost přímého nárazu do hrany výklenku v situaci, kdy řidič vozidlo neovládá. Šikmá plocha výklenku odráží vozidlo zpět na vozovku. Energie nárazu je tím snížena, stejně jako riziko zranění osádky vozu. Kromě ústí tunelových propojek jsou hydranty umístěny v blízkosti skříní SOS. Podél obou boků každé tunelové trouby vedou kabelové trasy umístěné do kabelovodů. Prostor kabelovodu je na povrchu upraven jako pochozí stezka a slouží jako úniková cesta.

The fire hydrants, as well as the manholes which allow clearing of the tunnel side drainage, are located in sidewall recesses. The edges of the recesses are chamfered in the direction of traffic so that the possibility of a direct impact into the edge of the recess in a situation when a driver loses control over the vehicle is prevented. The angling wall of the recess bounces the vehicle back to the roadway. Thus the impact energy as well as the risk of injury of the passengers is reduced. The hydrants are installed not only at the entries to the cross passages, but also at the SOS boxes. Cable runs lead through cableways along both sides of each tunnel tube. The surface above the cableways is provided with pavement and is used as a walkway and an escape route.

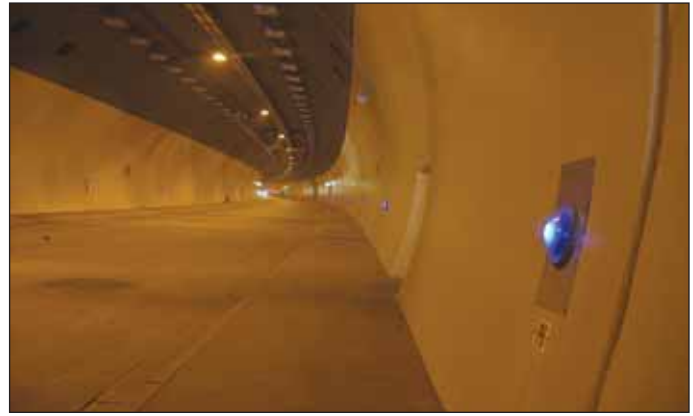
Obr. 9 Nouzové osvětlení a další vybavení tunelu  
Fig. 9 Emergency lighting and other tunnel equipment

V případě výpadku elektrické energie během normálního provozu v tunelu přechází režim osvětlení tunelu do náhradního osvětlení tunelu, zajišťovaného vybranými sekcemi akomodačního osvětlení. Dodávku energie zajišťuje náhradní zdroj a maximální povolená rychlost v tunelu je snížena z 80 km/h na 60 km/hod.

When the power failure occurs during normal tunnel operation, the tunnel lighting regime is switched to the stand-by tunnel lighting regime, which is provided by selected sections of the accommodation lighting system. The power supply is provided by a stand-by source, and the maximum permissible speed in the tunnel is reduced from 80 km/h to 60 km/h.
