TUNELY SILNIČNÍHO OKRUHU KOLEM PRAHY ZKUŠENOSTI PO ZAHÁJENÍ RAŽBY NA STAVBĚ 513 TUNNELS ON THE PRAGUE CITY RING ROAD EXPERIENCE AFTER THE COMMENCEMENT OF EXCAVATION IN CONSTRUCTION LOT 513

PETER ŠTEFKO, LIBOR MAŘÍK

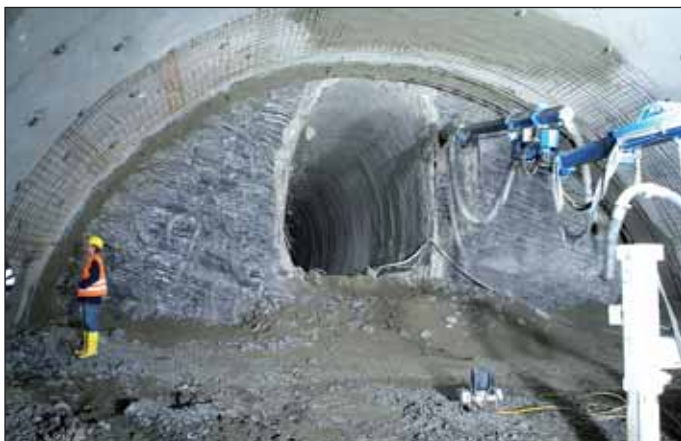
Obr. 1 Průzkumná štola situovaná ve středu kaloty jižního tunelu
Fig. 1 The exploration gallery found in the centre of the southern tunnel calotte

Před zahájením prací získal zhotovitel stavby výsledky geotechnického průzkumu, jehož součástí byla i ražba průzkumné štoly, situované ve středu kaloty jižního třípruhového tunelu (viz obr. 1). Stabilitu výrubu průzkumné štoly soudkovitého tvaru o ploše výrubu 25 m² zajišťuje primární ostění ze sřítkaného betonu vyztužené ocelovými sítěmi a vyztužnými příhradovými rámy. Štola o světlé výšce 5,5 m a šířce 4,5 m probíhá v celé délce jižního tunelu a umožňuje větrání i odvodnění podzemního díla během výstavby.

The contractor obtained the results of a geotechnical survey before the commencement of the work. Part of the survey was also the excavation of a geotechnical exploration gallery. The position of the gallery within the southern (three-lane) tunnel cross section was in the centre of the top heading (see Fig. 1). The stability of the exploration gallery excavation (a barrel-shaped cross section, the excavated cross-sectional area of 25 m²) was provided by a primary lining consisting of shotcrete, mesh and lattice girders. The gallery with the net height of 5.5m and net width of 4.5m runs throughout the length of the southern tunnel; it makes the ventilation and drainage of the underground working during the construction possible.

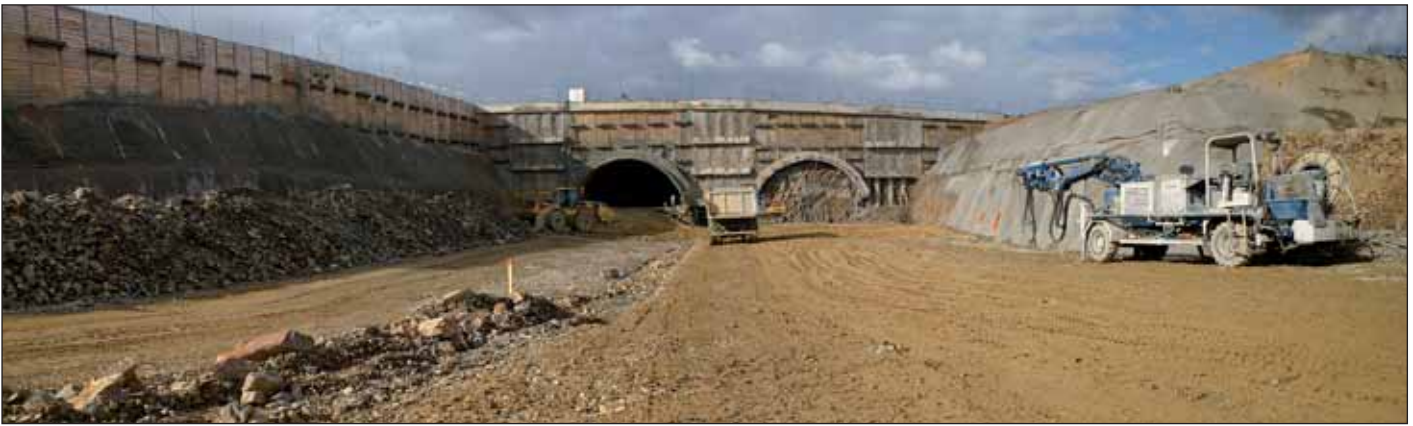
Obr. 2 Pohled na Cholupický portál a stavební jámu
Fig. 2 A view of the Cholupice portal and the construction trench

V době přípravy textu článku byla stavební jáma na Cholupickém portále délky 85 m a hloubky až 17 m vytěžena na úroveň kaloty tunelů a na portálech vrcholily přípravy pro zahájení úpadní ražby (viz obr. 2). V jižním tunelu bylo vyraženo 106 m kaloty. V komořanské stavební jámě délky 170 m a hloubky téměř 30 m probíhaly práce na zajišťování svahů záporovým pažením a odtěžování zeminy. V jižním tunelu bylo k 15. 11. 2007 vyraženo 867 m kaloty a s odstupem cca 400 m za čelbou kaloty odtěženo 478 m jádra v levé a 488 m v pravé části tunelu.

At the time when this paper was being prepared, the excavation of the construction trench at the Cholupice portal (85 long and up to 17m deep) was completed to the level of the calotte of the tunnels; preparation operations for the commencement of the downhill excavation culminated at the portals (see Fig. 2). The southern tunnel had 106m of the top heading excavation completed in the direction from Cholupice. The slopes of the 170m long and nearly 30m deep Komořany construction trench were supported by soldier beam and lagging walls and the excavation proceeded. As of 15.11.2007, the length of 867m of the top heading was completed in the southern tunnel, with the bench excavation proceeding at a distance of about 400m from the top heading face, using the staggered sequence for the left side and right side of the tunnel (the advance lengths of 478m and 488m respectively).

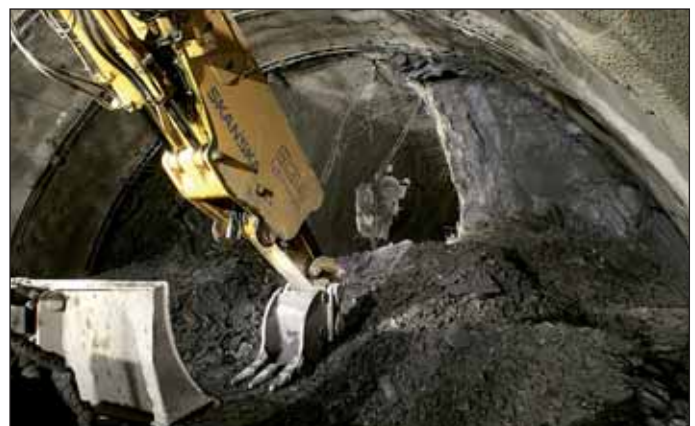
Obr. 3 Geologické poměry na čelbě jižního tunelu
Fig. 3 Geological conditions at the excavation face in the southern tunnel

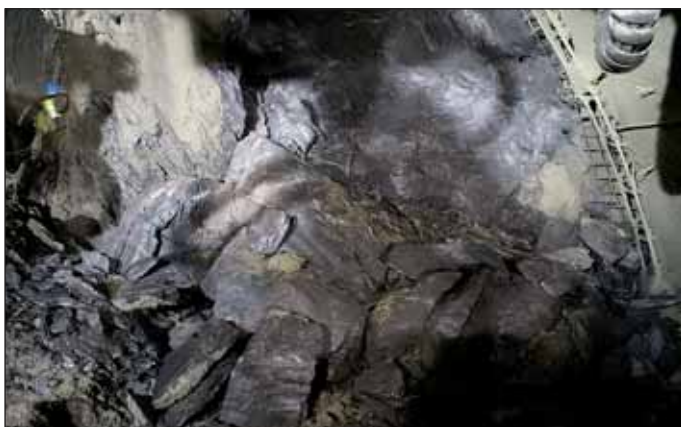
Obr. 4 Nestabilita čelby při nepříznivém sklonu vrstev

Fig. 4 The excavation face instability due to the unfavourable dipping of rock layers

and mechanical scaling – removing of loose rock from the excavated surface. Complete rock blocks are abruptly released in the especially unfavourable geotechnical conditions, which could threaten the safety of workers (see Fig. 4). In such cases the contractor stabilises the excavation face locally by anchors and shotcrete. Despite the measures contained in the design, local, geologically conditioned overbreaks occur. They are documented in the presence of the owner and contractor and the contractor takes care of a remedy as quickly as possible. The occurrence of overbreaks is rather sporadic. In general, the rock mass displays a high level of stability. The measured deformations of the excavated surface become stable very quickly and, once the full profile excavation is completed, they usually do not exceed 10mm.

Ražba jižního tunelu byla zahájena dne 2. 4. 2007 rozšířením výhybný průzkumné štoly (viz obr. 7). Nedostatek prostoru omezoval počátku výkony a ražba probíhala v technologické třídě výrubu 5a s modifikací bez spodní klenby. Délka záběru v kalotě se pohybovala do 1 m. Primární ostění výhybný štoly zasahovalo do profilu tunelu a muselo být po jednotlivých záběrech odstraněno. Rychlost ražby se pohybovala do 1 m za den. Po vytvoření dostatečného manipulačního prostoru a zlepšení geotechnických podmínek ve větší vzdálenosti od portálu se výkony zvyšovaly až na 2 záběry kaloty za den s průměrnou rychlostí ražby 4,2 m/den (max. 5,4 m/den). I když celkově vykazoval horninový masiv vysokou stabilitu, docházelo při prodloužení délky záběru k nežádoucím nadvýrubům způsobeným lokálním vypadáním bloků horniny po plochách diskontinuit, a to jak na lici výrubu, tak z čelby (viz obr. 4).

The excavation of the southern tunnel started on 2.4.2007 by operations enlarging the exploration gallery to the dimensions of the passing bay (see Fig. 7). A lack of space limited the outputs at the beginning; the excavation passed through excavation support class 5a, with the modification without invert. The advance per cycle was up to 1m. The primary lining of the passing bay protruded into the tunnel profile and had to be removed after the individual advances. The excavation advance rate was up to 1m per day. Once a sufficient manoeuvring space had been created and the geotechnical conditions had improved (at a greater distance of the portal), the outputs improved reaching even two top heading advance rounds per day, with the average advance rate of 4.2m per day (maximum 5.4m/day). Despite the fact that the rock mass displayed high stability, undesired overbreaks occurred in the cases of extended lengths of the excavation rounds; rock blocks locally slipped down along discontinuity surfaces, both from the excavated tunnel surface and the excavation face (see Fig. 4).

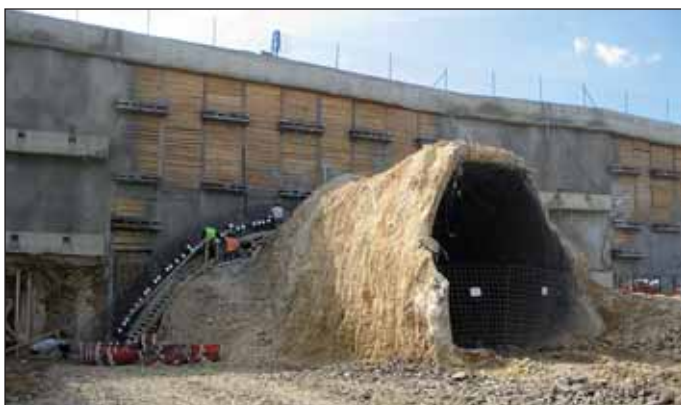
Obr. 6 Bourání ostění průzkumné štoly v oblasti jámy Cholupice

Fig. 6 The demolition of the exploration gallery lining in the area of the Cholupice construction trench

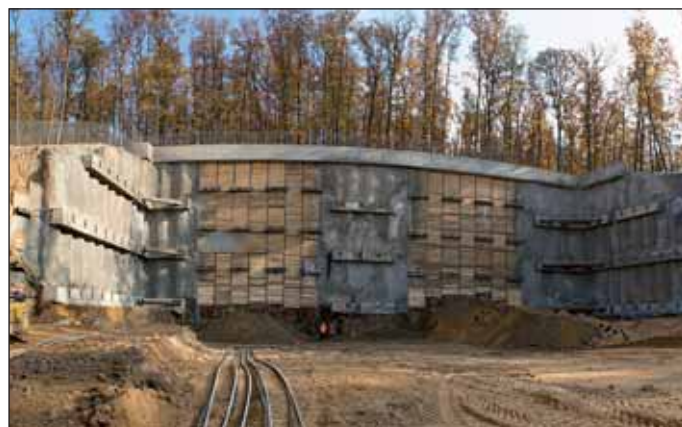
Obr. 5 Pažení stavební jámy Komořany

Fig. 5 Komořany construction trench partition

Stavební jáma níže položeného Komořanského portálu dosahuje hloubky 29 m a délka hloubených tunelů přesahuje 170 m (viz obr. 5). Zajištění boků stavební jámy

The construction trenches for the lower, Komořany portal is 29m deep as a maximum, and the length of the cut-and-cover tunnels is over 170m (see Fig. 5). The support of the sides of the trench is installed from a pre-excavated trench, which has its sides reposing at natural slopes; piles and soldier beams stabilising the sides of lower parts of the construction trench are installed from the bottom of the pre-trench. Despite the fact that the geological survey forecast the base of the cover to be at a shallow depth under the construction trench, an additional survey showed that the sandy alluvium formed in the past by the Vltava River is thicker and neither the piles nor the soldier beams could be keyed into the bedrock. The fact that the layer of sandy sediments was the only material which is encountered throughout the depth of the construction trench affected the dimensions of the piles, soldier beams and the method of the anchoring of the walls. The change in the geological conditions, together with the limited width of the plan area of temporary works led to a change in the system of the construction trench support. Deeper vertically supported sides were designed within the framework of the design of means and methods, at the expense of the sloped portion of the trench depth. The portal wall is formed by large-profile piles \varnothing 1180mm, which were drilled outside the profiles of the tunnels, and a soldier beam and lagging wall, which was carried out above both tunnels. While the piles reach 3.5m under the bottom of the trench, the toes of the soldier beams are stabilised by a reinforced concrete waler, which is connected with a canopy tube pre-support. The pre-support consists of 15m long, 108mm diameter steel tubes forming an umbrella above the top headings of both tunnels. The piles and soldier beams are connected at the top of the walls by one capping piece. The portal walls are supported by five tiers of stranded anchors passing through reinforced concrete or steel walers. The excavation of the construction trench is divided into stages with the levels of benches corresponding to the needs of the technology of the installation of the retaining walls, casting of walers and pre-stressing of anchors. There is the exploration gallery in the area of the construction trench and the future southern tunnel. The gallery lining must be demolished during the course of the excavation of the trench. The rock pillar is only 9.5m thick at the portal of the mined tunnels, which places increased demands on the stabilisation of the works at the beginning of the excavation of both the southern and northern tunnel.

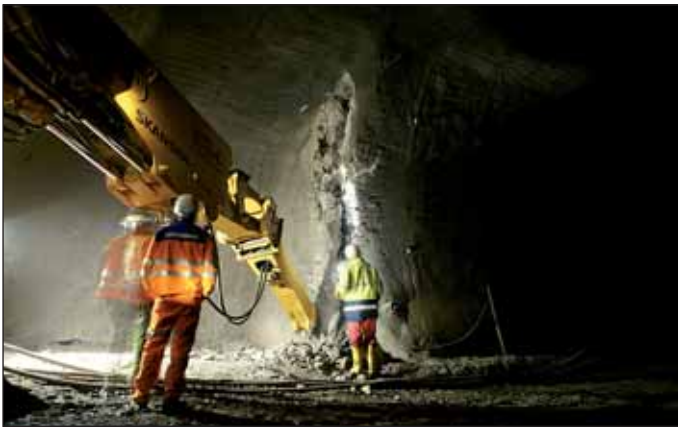
Obr. 7 První úder bouracího kladiva při zahájení ražby ze štoly
Fig. 7 Initial blows by the impact hammer on the commencement of the excavation from the gallery

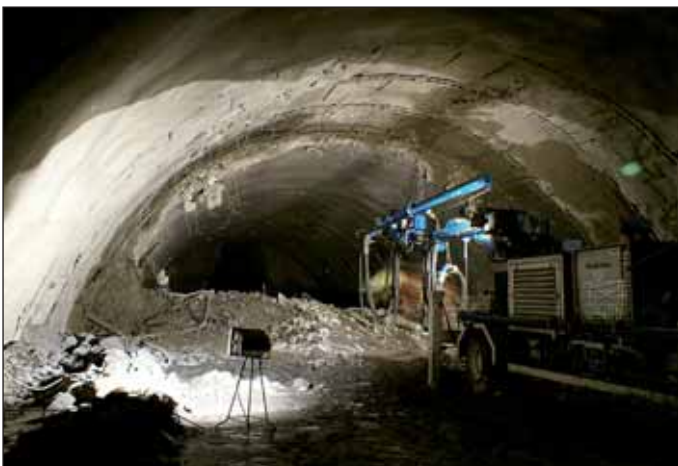
Obr. 8 Bourání ostění průzkumné štoly v přístropí kaloty
Fig. 8 Demolition of the exploration gallery lining in the top heading crown
